# Oil City Library Building Investigation & Study

Prepared for the  
Oil City Library Commission  
2 Central Avenue  
Oil City, PA 16301-0128  
814-678-3042

11/02/2009

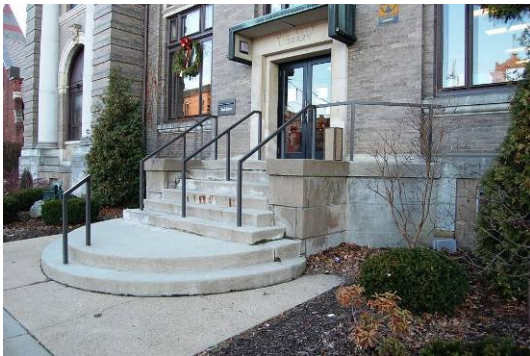
Figure 3

The primary site entry points are located on Central Avenue via stairs (Figure 3) and West Front Street via ramp (Figure 4). The West Front Street entrance ramp fails to meet current accessibility requirements and the Central Avenue stair is in poor condition and poses safety hazards for library patrons. The remediation of these items will create better site and building access.

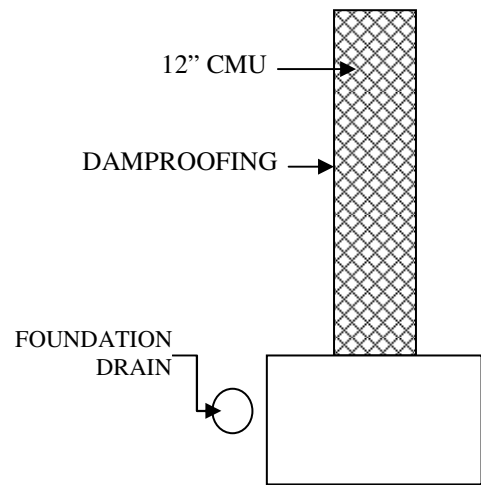
Figure 6

Overall the exterior walls of the entire library building are sound and in excellent condition. Caulking at expansion and control joints should be replaced to limit air, insect, and contaminant infiltration. Because there is a basement located below grade water infiltration is a concern. When the 1978 addition was constructed the new walls were damproofed on the exterior side and a foundation drain installed, see Figure 6. During the 1978 construction the 1904 basement walls were coated with a damproofing material on the interior exposed faces. There is no record of foundation drains for that part of the building. Likely they were constructed but have since been abandoned. Water infiltration into the basement seems to be minimal and can be addressed by installing new damproofing on the basement walls and adding dehumidification to the HVAC system.

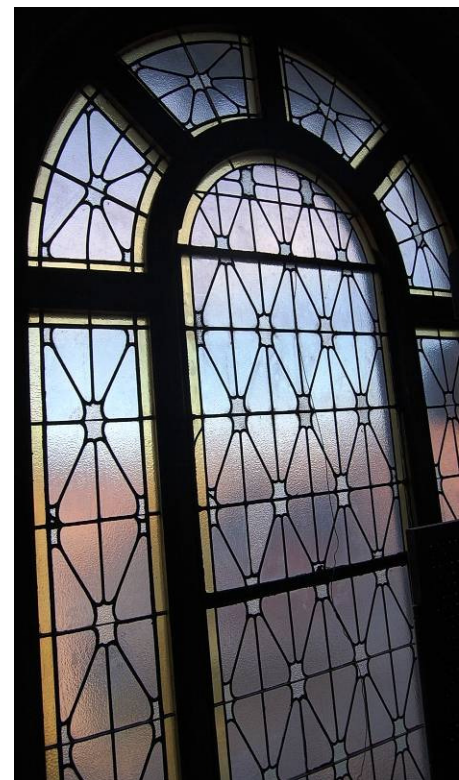
Figure 7

The existing windows in the Carnegie Library building are constructed using wood frames and single pane plate glass. Many of the windows have been fitted with storm windows in filled with plate glass or Plexiglas. One of the Carnegie Library building's greatest architectural elements is the large windows including multiple stained glass windows located on the second floor, see Figure 7. These elements have been largely marginalized because of the addition of poorly planned energy conservation means and methods. The 1978 windows are constructed using an aluminum frame in-filled with 1" insulated glazing. The windows are sound but lack today's high performance energy capabilities.

Window efficiency is measured using several factors primarily U-Value and Solar Heat Gain Coefficient (SHGC). Higher numbers represent poorer performance. The current glazing has a U-Value of approximately .55, this translates to an R-Value of 1.8(1/.55) and an SHGC of .7 and therefore allows 70% of the direct solar radiation to pass through the window. Current glazing systems feature U-Values of .30 equaling an R-Value of 3.33 (1/.30) and an SHGC of .22 allowing only 22% of direct solar radiation to pass through the window. The current windows also lack any kind of low emissivity coating. Low-E coatings can reduce temperature gain on the interior of the building by 4 to 5 degrees. These figures represent significant improvements and lower heating costs. Replacement of the existing windows and proper opening weatherproofing would help reduce heating and cooling costs, improve user comfort, and expose the building's impressive millwork which has been covered over with ineffective storm windows.

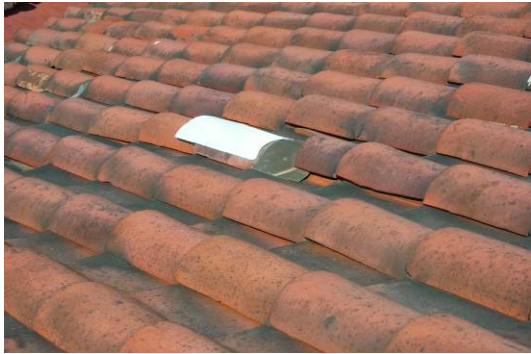
**Figure 8**

The roof is divided into two major areas. One covers the original Carnegie Building and consists of clay tile and slate. This part of the roof is in poor condition and several temporary fixes have been attempted, see Figure 8. Currently leaks into the Carnegie Building second floor space are causing damage to ceiling and wall finishes. Complete roof integrity is required before renovations can take place on the ground and upper floors.

The replacement of the roof is a prerequisite for any planned building renovations and should be a high priority item.

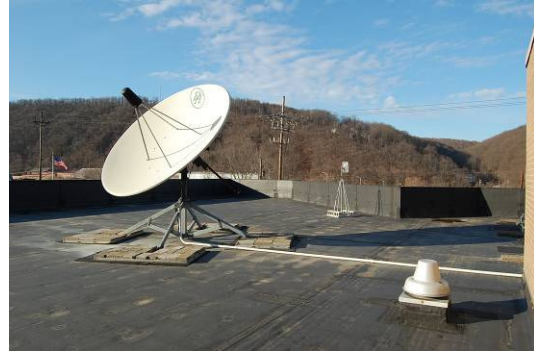
**Figure 9**

The second roof area covers the 1978 addition and consists of flat rubber roof and small sloped roof protected by slate. Both of these roof surfaces are in good condition, see Figure 9.

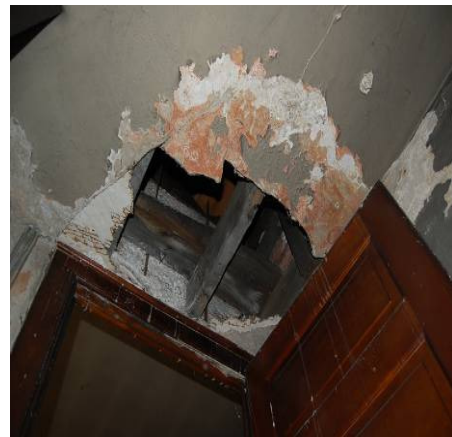
**Figure 10**

The interior partitions have been well maintained except for the second floor storage area of the original Carnegie Library Building; a large portion of the 2<sup>nd</sup> floor has been used for storage since 1979. In this location the walls and plaster ceilings have deteriorated drastically due to non-use and water infiltration from leaks in roof, see Figure 10.

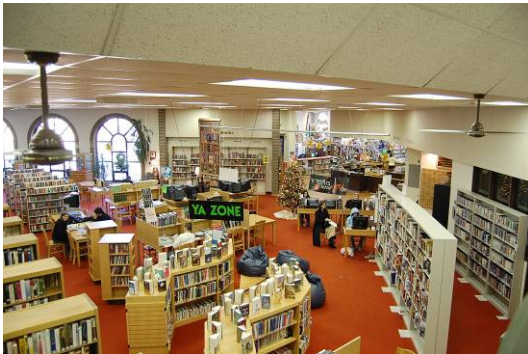
**Figure 11**

The primary wall finish is a shade of white paint, see Figure 11. The custodial staff does an admirable job of keeping the walls clean and blemish free. Specifying a higher wear resistant paint could reduce scheduled paintings and maintenance. The introduction of a more vibrant color scheme would improve building aesthetics and user comfort.

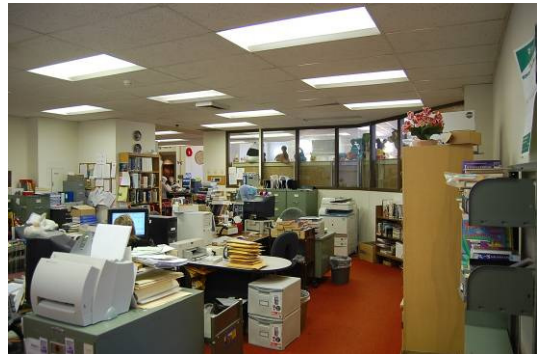
**Figure 12**

The library has a multitude of furniture styles especially in the office areas, see Figure 12. Systems furniture should replace the collection of non functional and uncomfortable office equipment to increase productivity and reduce space requirements. Shelving comprises the greatest percentage of furniture items. The current shelving is adequate but in many cases fails to meet accessibility standards due to shelf heights exceeding a maximum of 48". A variety of

computer desks are also in use throughout the library. A phased furniture plan should be implemented to replace worn out and mismatched pieces. The original library featured solid wood furniture that was designed as part of the building creating a unified aesthetic. A return to a cohesive furniture and interior design strategy will help to enhance user experience and library aesthetics and efficiency.
