# Oil City Library Building Investigation & Study

Prepared for the  
Oil City Library Commission  
2 Central Avenue  
Oil City, PA 16301-0128  
814-678-3042

11/02/2009

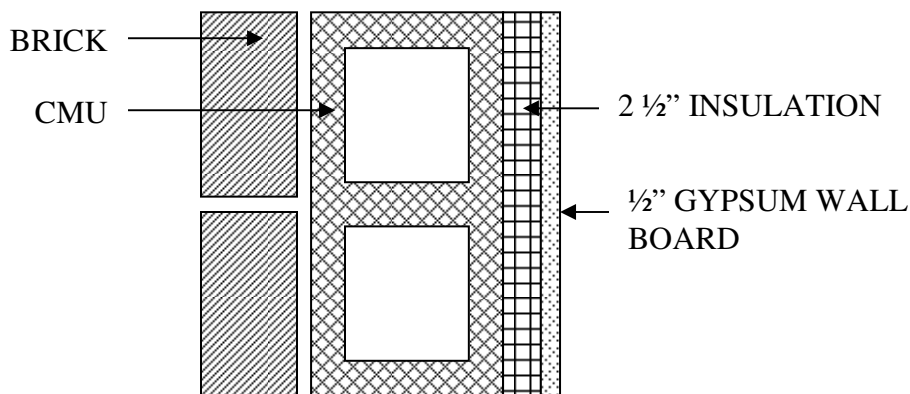
Figure 5

The 1978 Library Addition walls are constructed as illustrated in Figure 5.

Overall the exterior walls of the entire library building are sound and in excellent condition. Caulking at expansion and control joints should be replaced to limit air, insect, and contaminant infiltration. Because there is a basement located below grade water infiltration is a concern. When the 1978 addition was constructed the new walls were damproofed on the exterior side and a foundation drain installed, see Figure 6. During the 1978 construction the 1904 basement walls were coated with a damproofing material on the interior exposed faces. There is no record of foundation drains for that part of the building. Likely they were constructed but have since been abandoned. Water infiltration into the basement seems to be minimal and can be addressed by installing new damproofing on the basement walls and adding dehumidification to the HVAC system.
